# **Flexural performance of reinforced concrete beams strengthened with fibre reinforced geopolymer concrete under accelerated corrosion**

## **Abstract:**

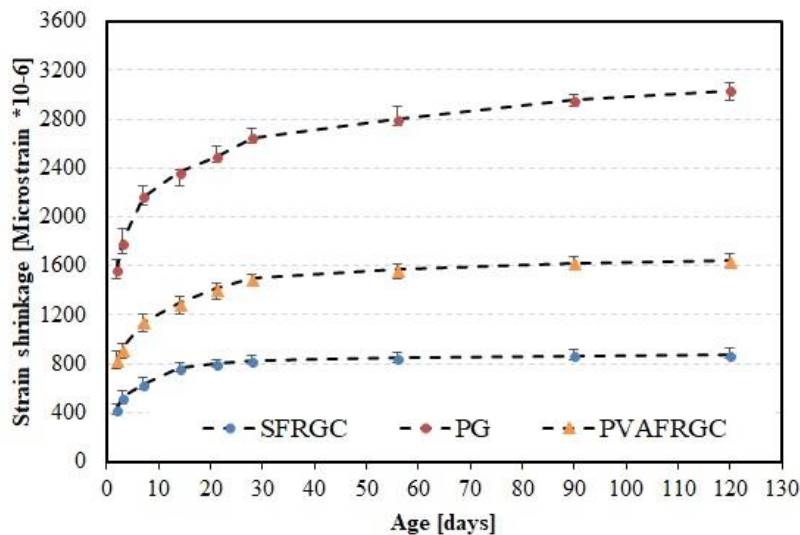
**Figure 3.** Dry shrinkage results up to 120 days.

Based on the results of Fig. 3 it is evident that the drying shrinkage strain of the PG mortar is very high (around 3000 microstrains) at 120 days, which is in agreement with previous studies [39, 40]. The addition of fibres leads to significant reduction in shrinkage strain values in both cases (i.e. PVAFRGC and SFRGC), especially with the addition of steel fibres (SFRGC). In the case of steel fibres (SFRGC) the shrinkage strain at 120 days was 850 microstrains, while in the case of PVA fibres (PVAFRGC) the respective value was found to be 1600 microstrains. This reduction is attributed to the physical restraint provided by the presence of the fibres in the geopolymer matrix, which is in agreement with previous studies on conventional fibre reinforced concrete [41]. Li *et al.* [41] reported that the reduction of drying shrinkage strain is considerably affected by the volume fraction of the fibres. Atis *et al.* [42] supported this finding and reported that the use of steel fibre restrained movements at the micro level in the case of fly ash and OPC based concrete by bridging and stitching fine shrinkage cracks.

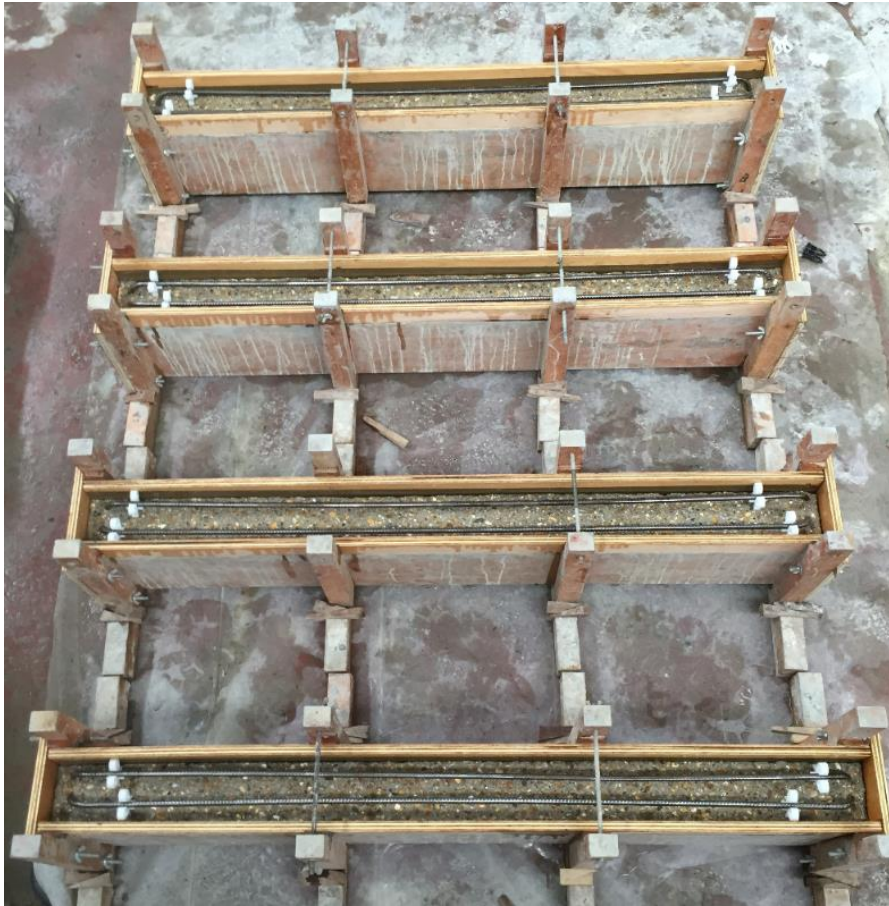
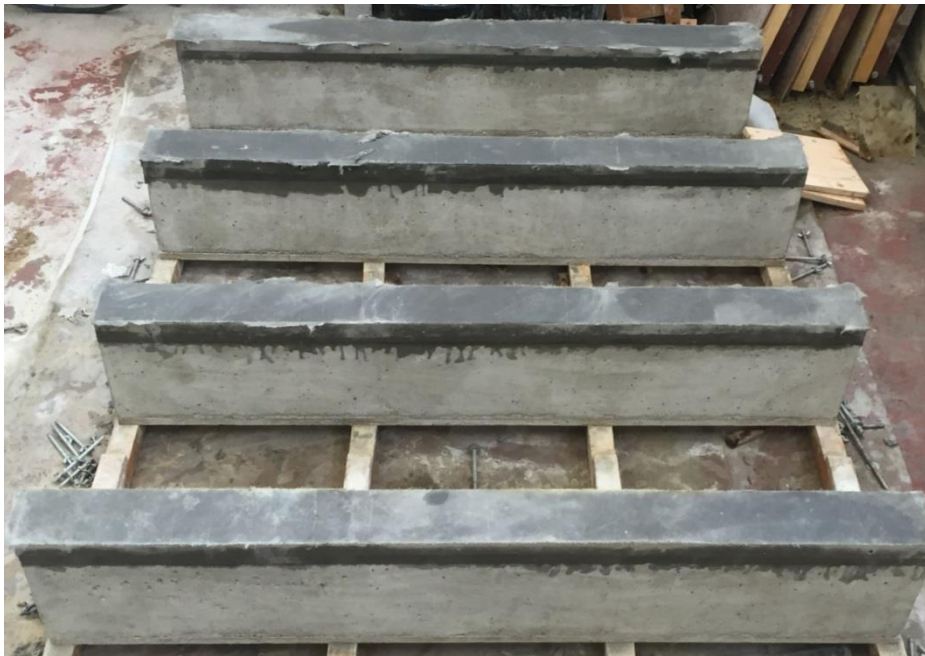
**Figure 6.** RC beams **a)** before and **b)** after casting of the strengthening layer.

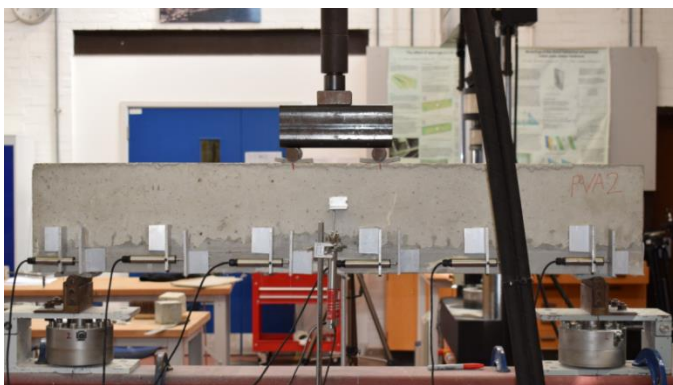
**Figure 12.** Experimental set up showing the distribution of LVDTs for RC beams.

Each LVDT was glued to the substrate beam and was in contact with a metal angle section that was glued to the strengthening layer. The lateral LVDTs were mounted on the concrete surface at the supports and then at incremental distances of 250 mm towards the centre as shown in Fig. 12.

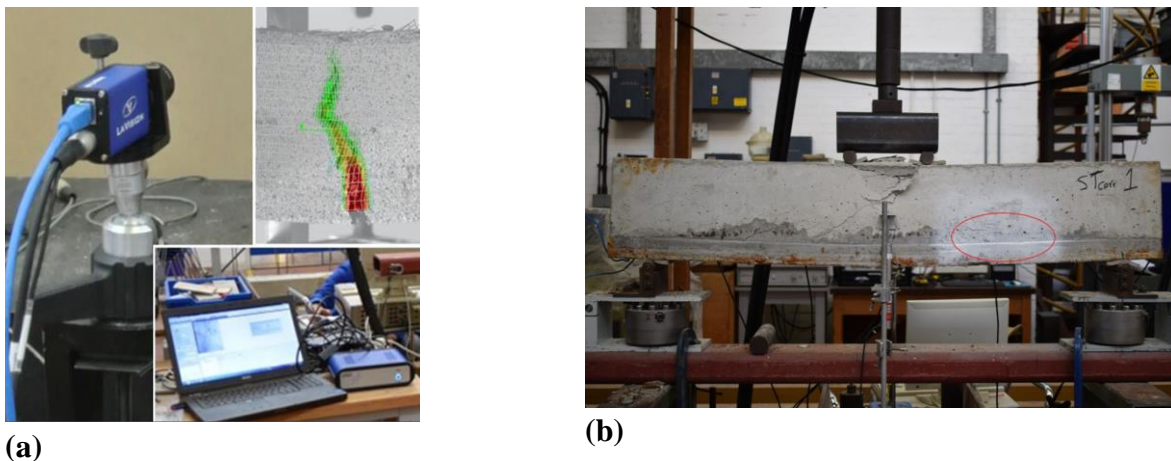
**Figure 13.** a) Digital Image Correlation system and b) experimental setup during testing.

All readings were continuously collected by data-acquisition systems during the test until the failure of the beam. In addition to the LVDTs, a Digital Image Correlation System (Fig. 13a) was used for the monitoring of part of the interfaces at a distance 250 mm to 500 mm from the end of one side of the beam, at the opposite side to where the LVDTs were placed (Fig. 13b).

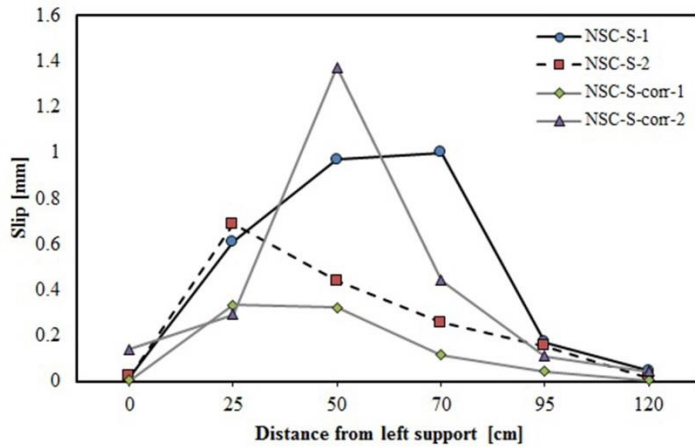
**Figure 22.** Interface slip measurements at peak load for strengthened RC beams with NSC overlay.

The interface slip measurements along the beam length for RC beams strengthened with NSC, PVAFRGC and SFRGC respectively are presented in Fig. 22, 23 and 24.

By comparing Fig. 22, 23 and 24, it is obvious that overall lower maximum slip values were observed in the case of specimens strengthened with reinforced PVAFRGC and SFRGC layers, compared to the respective results of specimens strengthened with reinforced NSC layers. This confirms the improved interface conditions of the specimens strengthened with PVAFRGC and SFRGC layers. The interface slip measurements at the supports were found to have the smallest values, which increased as bending cracks began to propagate through the interface towards the mid-span of the beam. There is significant scatter in interface slip measurements in duplicate specimens, and specimens did not behave consistently along the whole length of the specimen, due to the slip measurement depending on crack propagation and failure mode.

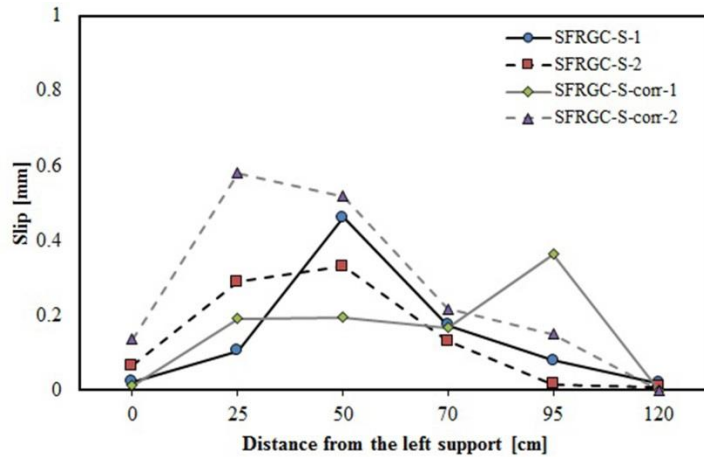
**Figure 24.** Interface slip measurements at peak load for strengthened RC beams with SFRGC overlay.
